## CASE STUDY

## REMEDIATION OF HYDROCARBON CONTAMINATION

Former Swimming Pool Site, Elgin

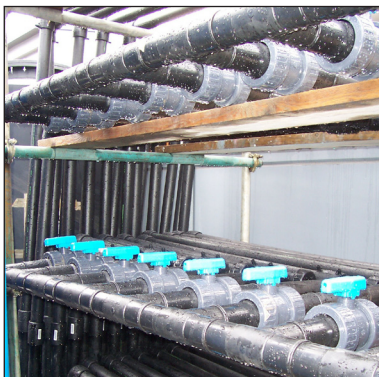
- ERS engineers designed a bespoke remediation system allowing remediation to be undertaken both whilst construction continued and once construction was complete and the site was operational.
- A bioslurping plant utilising high vacuum to control the water table, exposing the smear zone, enhancing volatilisation of the contaminants and encourage air flow to further enhance bioremediation. This was implemented using a permanent infrastructure of 36 wells focussed to the bioslurping plant.
- Monitoring of bio-activity was undertaken by in-situ respiration testing within monitoring wells. This monitored oxygen consumption rate post purge using remotely-situated monitors. This allowed the progress of biological remediation to be tracked enabling ongoing system optimisation.

Successful implementation of fixed lance bioslurping allowed reduction of local groundwater and facilitation of aerobic biodegradation of contamination to meet the target criteria.
